Failure analysis of a steam condensate pipeline in 2nd refinery of South Pars Gas Complex

R.Danaei Moghadam^a, Peyman Salaryan^{*b}, Mehdi Bagherzade^a

Abstract

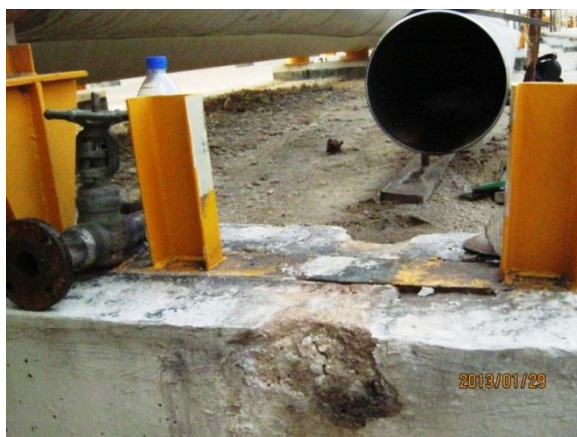
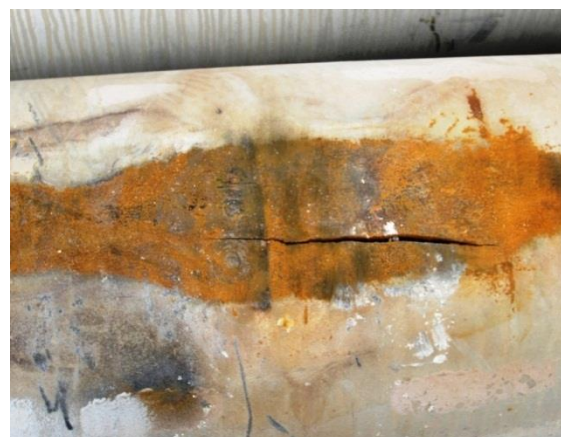
Failure of a pipeline (line no: 16"-CP-160-12101-B01-N) was reported in January 2013. Visual inspection showed a leakage on pipeline. A groove on pipeline was observed as well as, the concrete support was damaged. For more investigation, the pipeline was cut. Figure 1 showed a rupture on the pipeline and damaged support after cutting of the pipeline.

The pipeline supports were located in improper conditions. The piping should be worked according to ASME B31.3 (pipe support criteria for the above ground piping). The support of pipe should be able to absorb the loads arisen from fluid vibrations. Unfortunately, pipeline supports were not properly performed. As well as, improper function of the expansion loops led to move the load to the

Figure1. Damaged support (left) and rupture on pipeline at 6 o' clock position (right)

pipelines. The increase or the decrease in flow velocity can cause pressure vibrations. The changes of flow velocity can be caused by sudden closing of valves, start up and stop of pumps, control process, and pump power failure. As well as, the loads of steady state conditions, the pipeline, and affiliated equipment have a heavy dynamic loading. Pressure changes lead to vibration in pipelines. Vibration phenomenon in pipeline is called Hammering. Due to hammering phenomenon, many parts of the pipeline were severely damaged. Also, adjacent pipelines were affected by hammering phenomenon. In order to remove hammering effect, the installation of fix support (anchor type) is necessary. Fix supports (Anchor type) restrict pipeline expansion in the expansion loop. As well as, they remove longitudinal displacements. So, the installation of fix support leads to high efficiency of expansion loops.

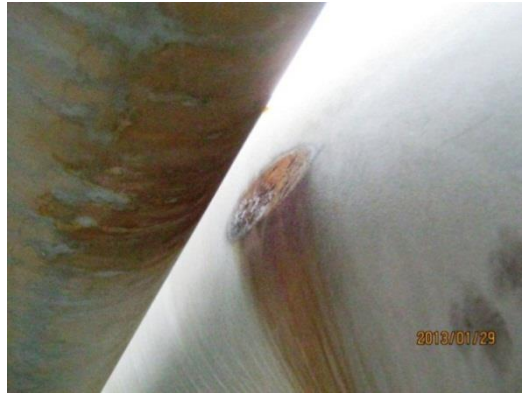
The concrete supports of pipeline were damaged. The pipeline was rubbed on adjacent pipeline and support. Figure 2 shows the damage on pipeline because of erosion on adjacent pipeline.

Figure2. The erosion of pipeline 16 inches on adjacent pipeline

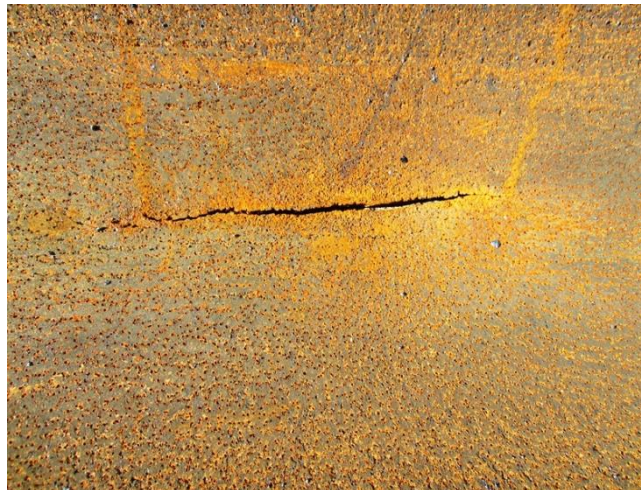
Figure4. Groove on the surface of pipeline

Figure 4 showed a grooving morphology. Grooving corrosion in steam and condensate streams is caused by synergy of two or more corrosion mechanism such as carbon dioxide and oxygen. Therefore, the groove on pipeline was caused by CO_2 and O_2 attacks.

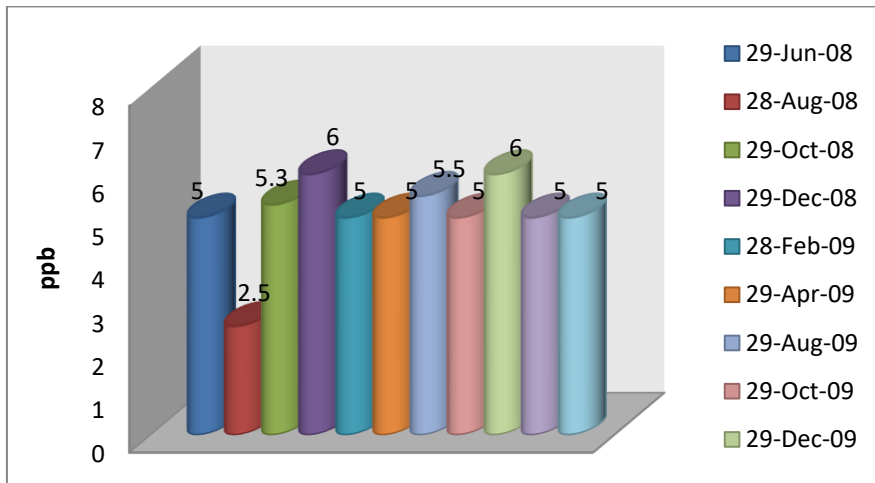
In order to investigate oxygen attack, the quality of feed water of boiler was measured. Figure5 shows the concentration of oxygen in boiler feed water. The results show that oxygen concentration is allowable according to Maximum allowable concentration of oxygen (7 ppb). For more investigation, some points inside steam condensate system should be measured for studying of oxygen concentration. Unfortunately, any data were recorded as daily for monitoring oxygen in the polluted steam condensate. Therefore, we cannot use experimental data for analysis. The concentration of oxygen should be sampled on site. Also the sample should be cooled for measurement. Other failure of this pipeline was reported in December 2013. Two points were failed. One point was on straight stream of pipeline and other was a tee. We were investigated morphology of corrosion after cutting of pipeline. Figure 6 shows the pitting on inner surface of straight stream of pipeline. As seen from this figure, the morphology of pitting looks like oxygen attack. As well as, yellowish deposits demonstrate this case.

Figure5. Concentration of oxygen in BFW

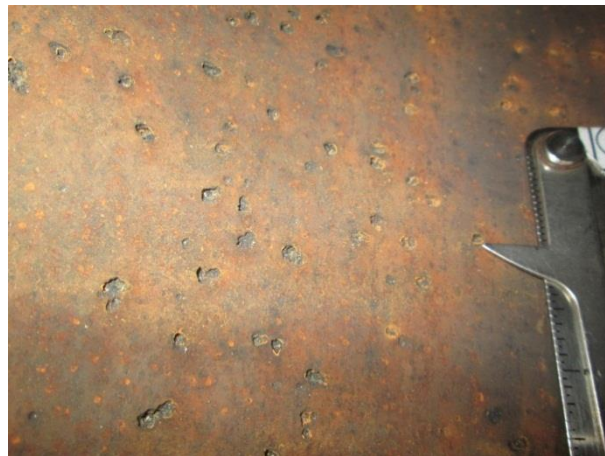
Figure6. The pitting on inner surface of straight stream of pipeline

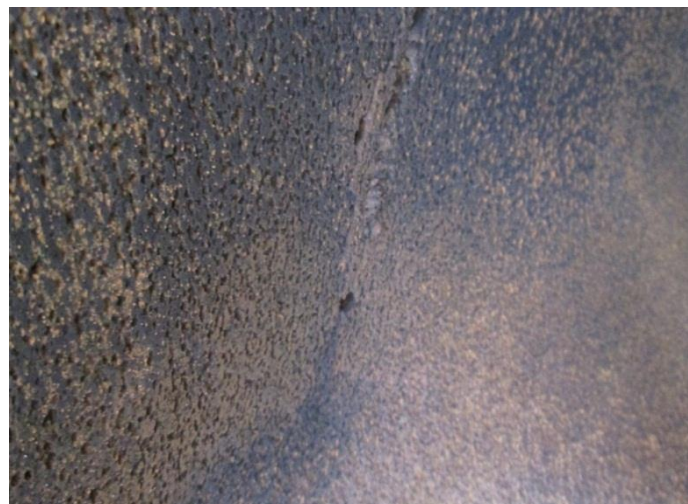
Figure7 shows inner surface of tee. As seen from this figure, morphology of corrosion is similar to cavitation. As well as, this morphology in tee section was occurred and in service time, pipeline had vibration. Therefore, it is clear that cavitation phenomena have significant effect on this failure.

Figure 7. Inner surface of tee
